INDIANAPOLIS FIRE DEPARTMENT

Overview

Garbage truck explosion in Indianapolis 27 January 2015

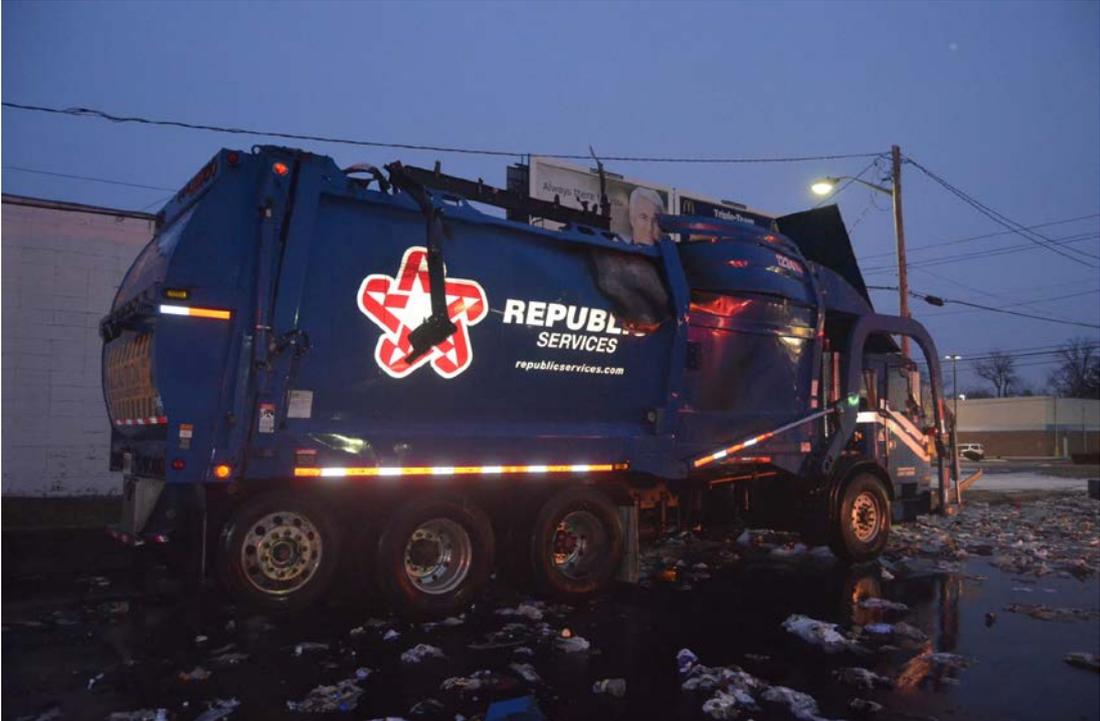
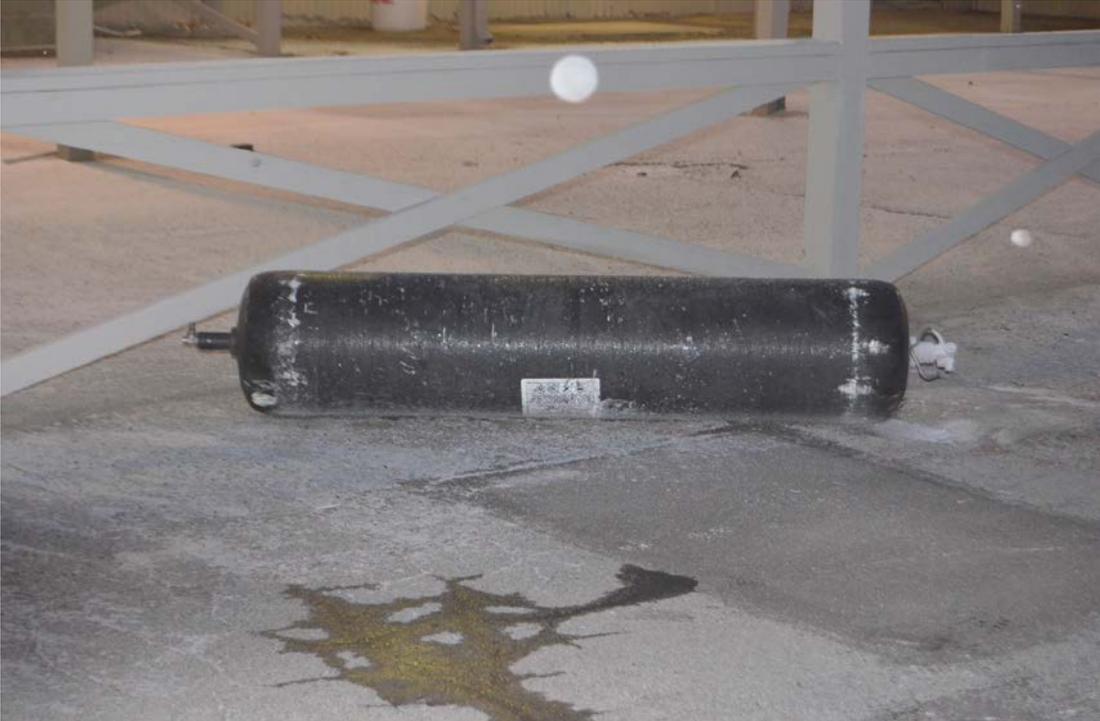
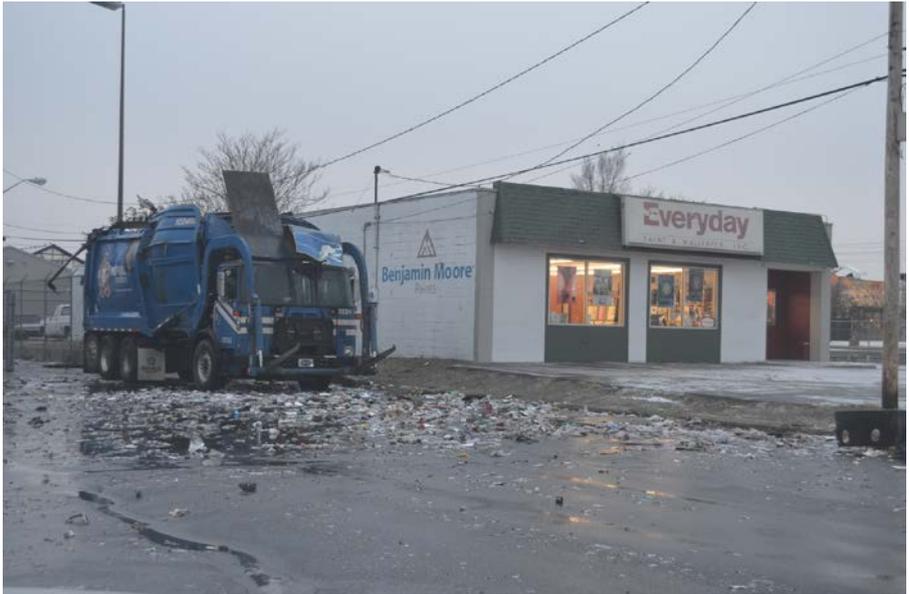
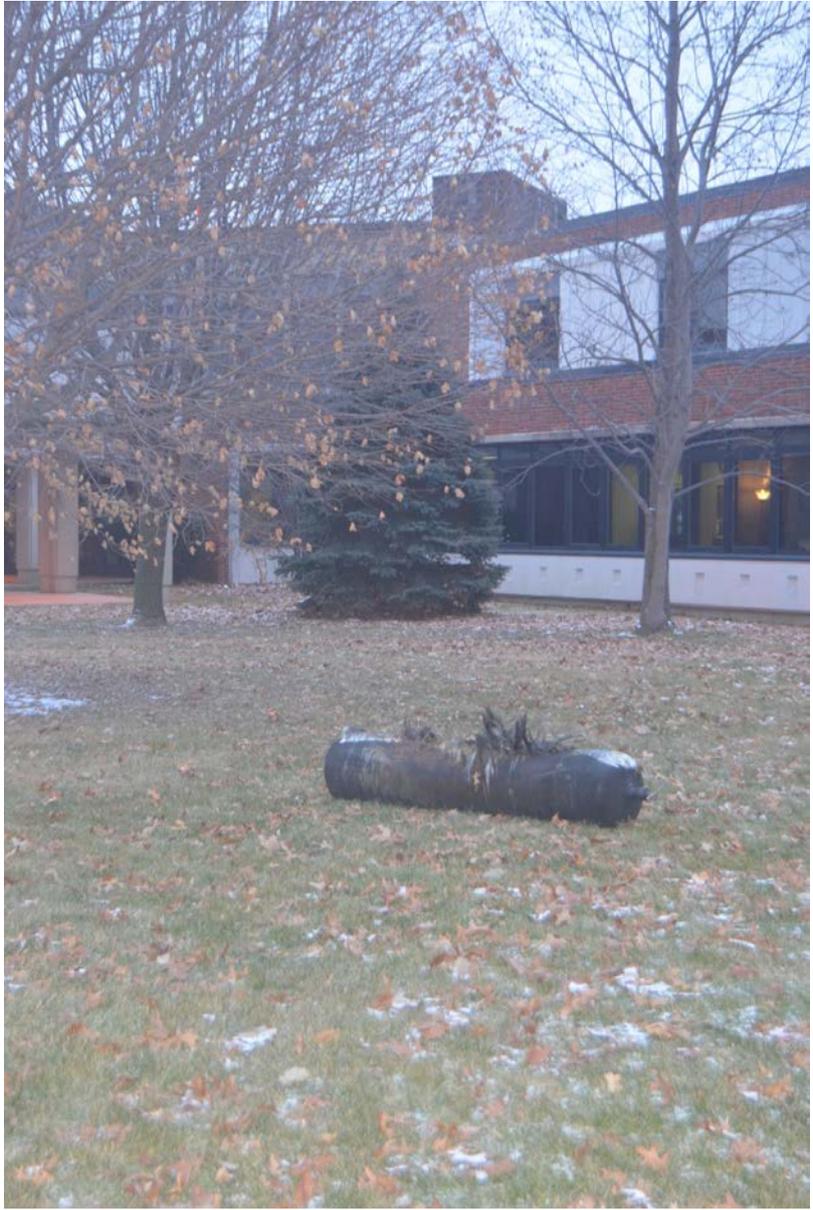
On 27 January 2015, 05:33 hours, the Indianapolis Fire Department responded to a reported trash compartment fire in a garbage truck. The incident location was 1498 E 86th Street. The vehicle contained Type 4 compressed natural gas (CNG) cylinders¹. These cylinders were located directly above the body of the vehicle (hopper) and were used to power the vehicle in lieu of fossil fuel. The fire was located immediately below the storage bin of the tanks.

The first arriving unit, Engine Co. 6, received information the fire involved compressed gas cylinders and requested additional resources at 05:45 hours. An elevated water stream was deployed to cool the tanks and contain the fire. The tank explosion occurred at 06:06 hours. The resulting debris field extended approximately three-quarter miles (1.2 kilometers) from the explosion site, with one CNG cylinder landing in front of a nearby school. Although firefighters were struck by debris, the only injury noted was a muscle strain. The vehicle involved sustained significant damage, with only minor damage to nearby structures.

As mentioned, this vehicle was equipped with Type-4 CNG tanks. Attached to each end of a cylinder is a thermally-activated pressure relief device (PRD), designed to operate between 212° F and 220° F (100° C and 104° C). The PRD is designed to relieve pressure in CNG containers in the event of a fire. It is important to note the PRD may not always activate in time to prevent any chance of a cylinder rupture in a fire. If the heat transferred to a cylinder is localized, intensive and remote to the relief device, or when fire builds rapidly, such as in an explosion, and is of very high intensity, the cylinder can weaken sufficiently to rupture before the relief device operates, or while it is operating².

Against normal procedure for fires involving in such vehicles, the driver was unable to “dump” the burning debris. This resulted in a the heat build-up directly under the cylinders. A contributing factor was a protective cover over the tanks. The cover likely hindered cooling the tanks and may have inadvertently caused the pressure reducing devices (PRD) to be cooled by the water stream and prevented their activation. It is speculated the water spray applied may have kept the PRDs below their intended trigger temperature.

From a tactical perspective, if a vehicle is known to be equipped with CNG cylinders and is well involved with fire, firefighters should maintain a safe perimeter and not approach the vehicle, unless there is a significant life hazard, i.e. let the vehicle burn. A minimum evacuation radius of 300 feet (90 meters) should be maintained in such incident types. As experienced in this event, a tank landed approximately

4,000 feet (1,200 meters) away. Do not approach from either the front or the side of the vehicle. If necessary, approach a CNG vehicle fire from a 45° angle.

If the PRD(s) have activated, do not apply water spray, but rather allow the fire to burn.
